Monitoring Data Record

Project Title: U-2307AD COE Action ID: 200031274
 Stream Name: UT to Miller Branch DWQ Numbers: 000914 and 001587
 City, County and other Location Information: Intersection of East Side Thoroughfare and Tate Boulevard in Hickory (Catawba Co.)
 Date Construction Completed: July 2003 Monitoring Year: (1) of 3
 Ecoregion: _____ 8 digit HUC unit: 03050101
 USGS Quad Name and Coordinates: _____

UT to Miller Branch

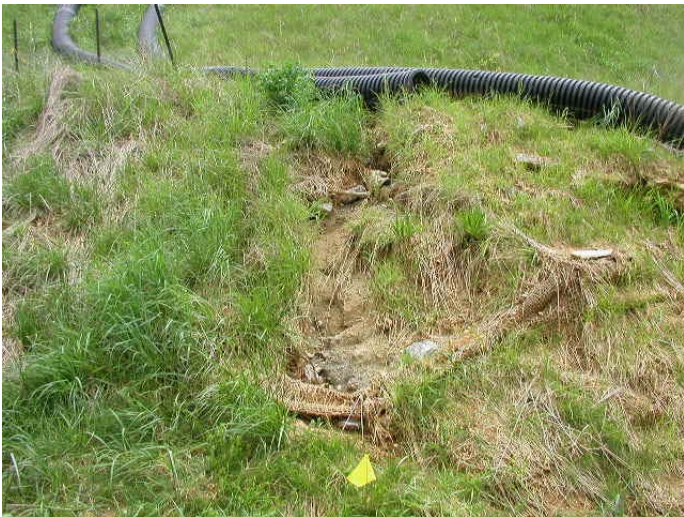
The pools below a few of the crossvanes are eroding. According to the Assistant DEO, these pools will be armored with rock to prevent this erosion. There is some minor erosion on the slope above the stream coming from a drainage pipe on the road project as noted in photo 9. RE Field Operations Engineer has been notified of this issue. The rest of the stream is stabilized at this time.

Photo 9 (slope erosion)
